# Individual Lab Report 4

Team A / The Avengers

ILR04

November 13, 2015

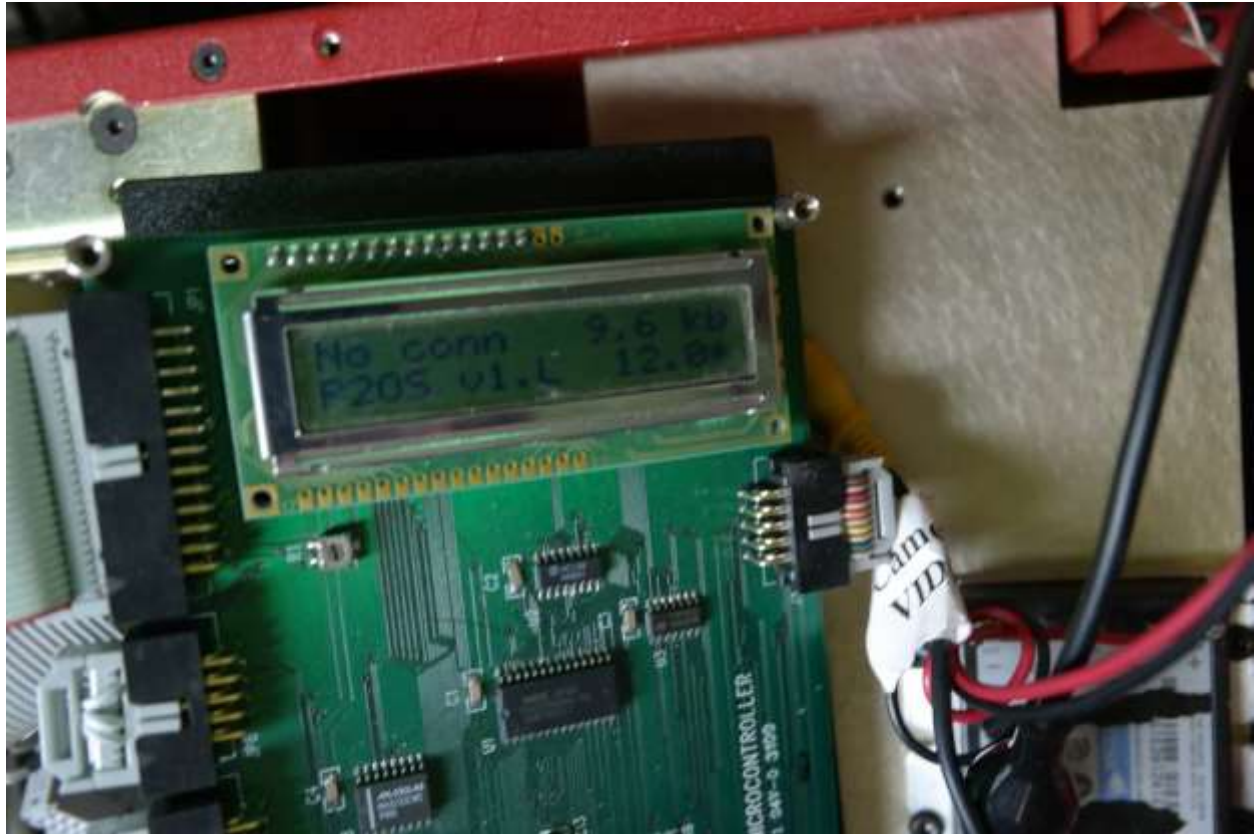
Figure 2: LCD Readout of Pioneer 2

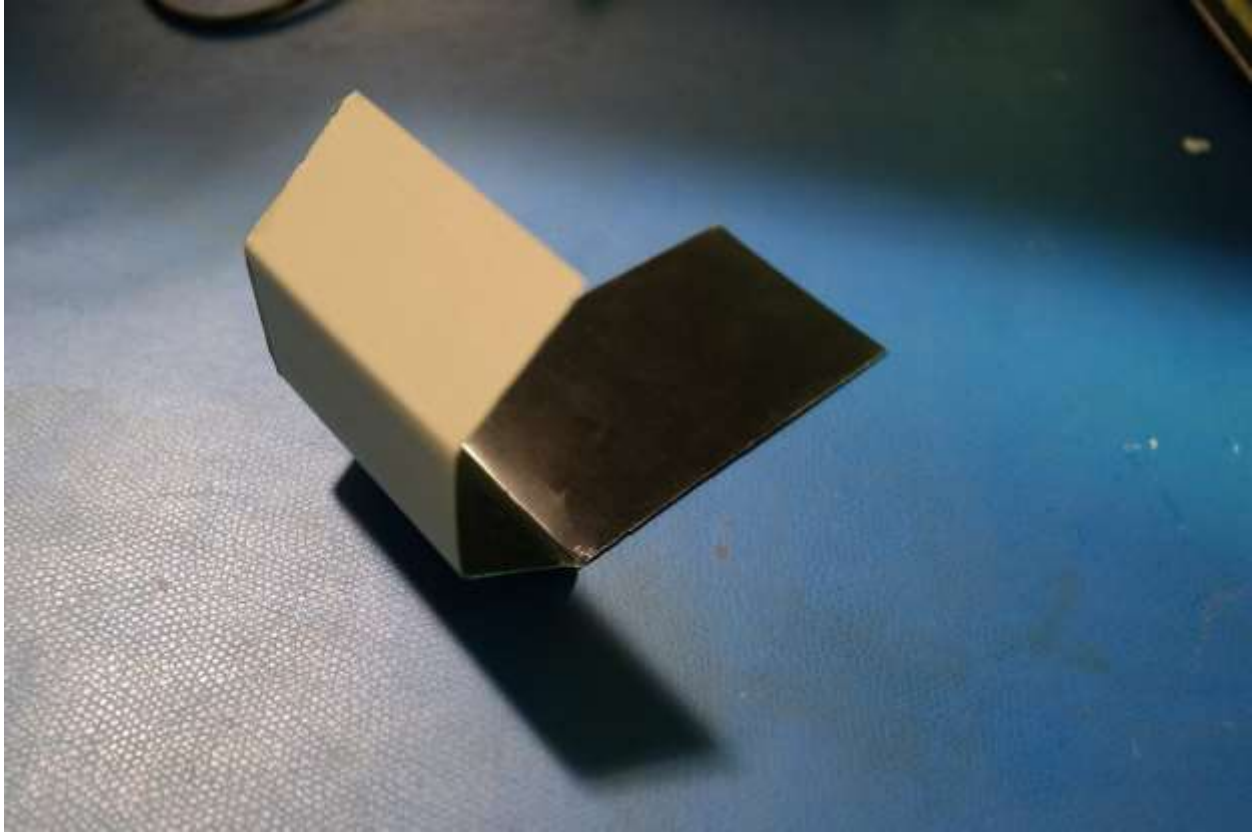
In order for Pratik to test sensor arrangements, I built several simple mounting brackets for him. The mounts were cut from a thin piece of sheet metal scrap found in the lab. An example can be seen in Figure 3.

Figure 3: Basic Sensor Mount

The long, flat portion of the mount attached to the drone mockup we've been using to test sensor and wiring layouts. IR and ultrasound sensors were mounted on the three smaller portions. In the arrangement shown, sensors could be angled at  $45^\circ$ ,  $90^\circ$  (horizontal), and  $135^\circ$  relative to the mounting surface. Through testing, Pratik settled on a slightly modified version of the above, angling the sensors at  $90^\circ$  (horizontal),  $135^\circ$ , and  $180^\circ$  (ground facing). The final setup can be seen in Figure 4.

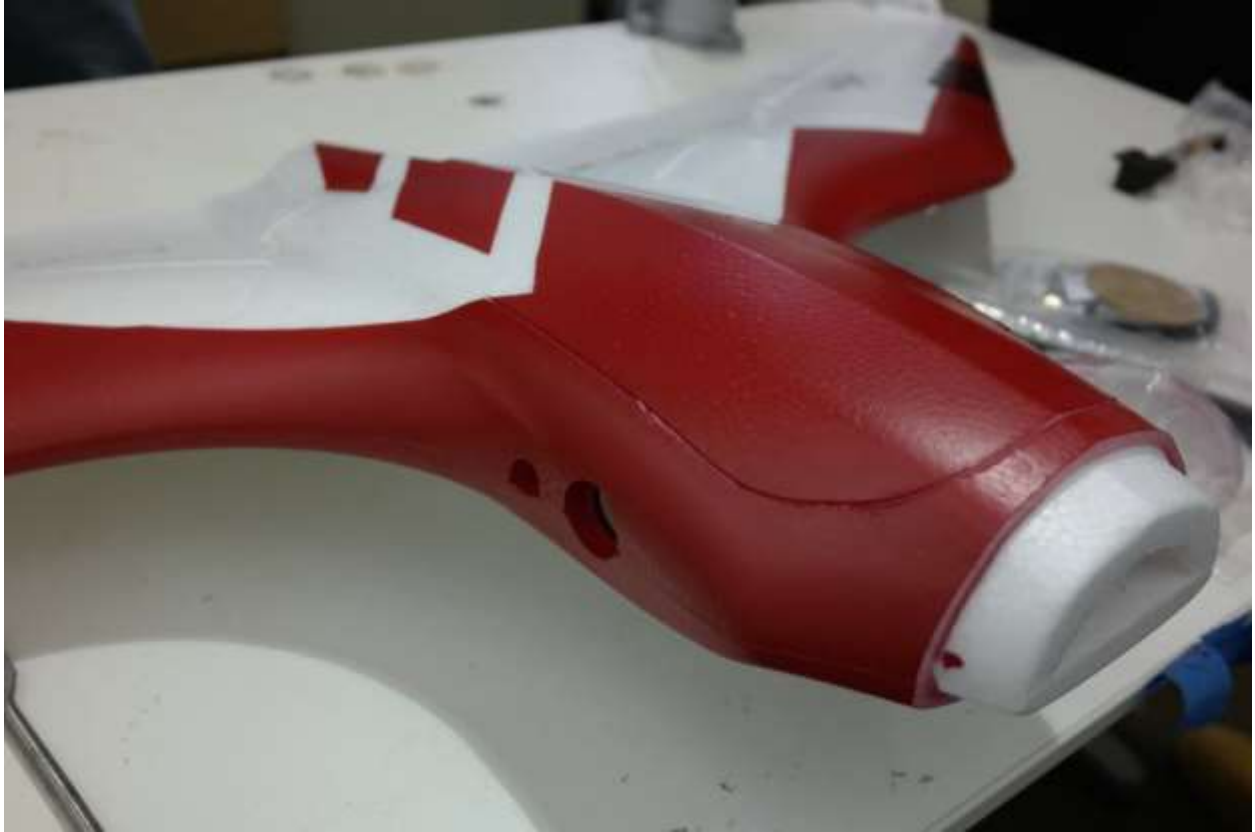
Building the FireFLY6, which arrived last Friday, was a team effort. The barebones hull and wings are visible in Figure 5.

Figure 5: Aerobot Out of the Box

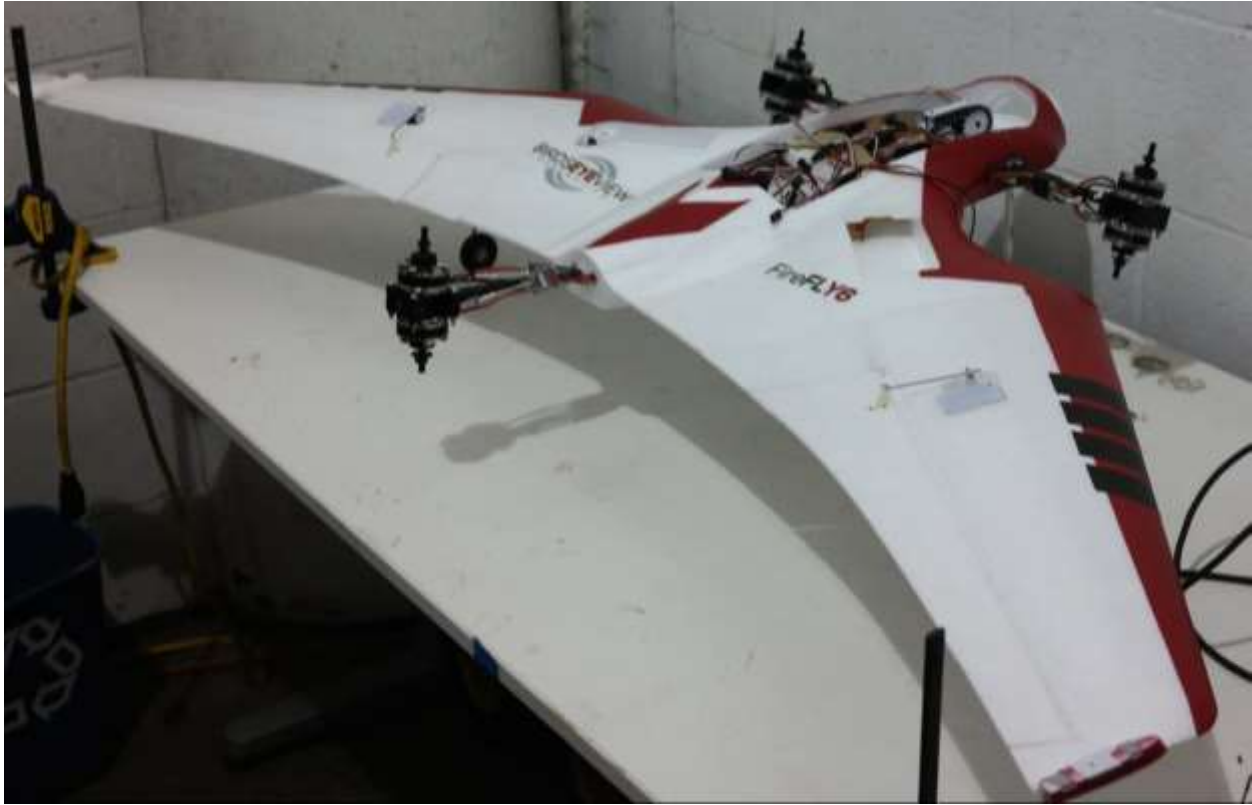
Assembly was a team effort with Adam directing the group's efforts. I provided the majority of the mechanical assembly, connecting the wings, routing wires, and mounting the motors. The current status is visible in Figure 6. Much of the work now is in configuring the PixHawk Flight Controller.

Figure 6: Partial Assembled FireFLY6
