ILR10 - Progress Review 11

Team G: The Pit Crew

November 13, 2020

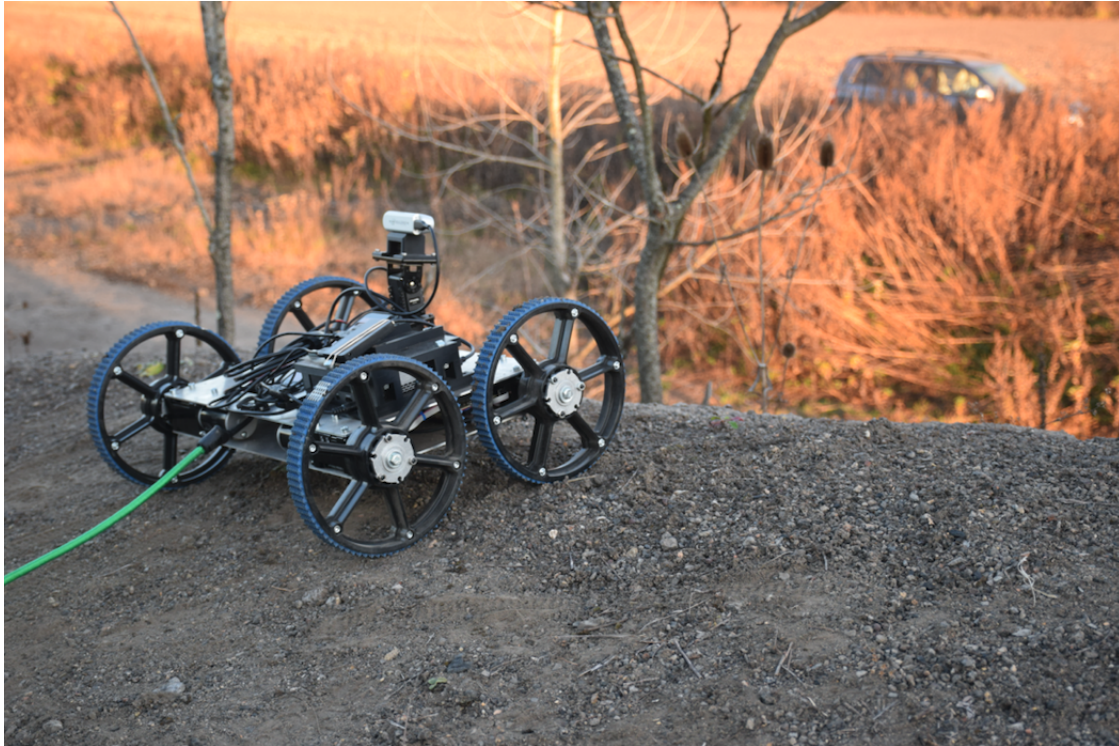
Figure 1: The surrogate rover, Blue, approaches a cliff edge at the Gascola site. Photo credit: Awadhut Thube

After fixing the bugs that we found, we were able to achieve our first complete execution of the Terrestrial Pit Edge Validation Test. The rover drove to three vantage points, used the brinkmanship subroutine to navigate close to the edge (as seen in Figure 1), then captured three panoramas at different tilt angles at each location. The first time this test was performed, the rover still stopped short of the cliff edge, beyond what we would consider

appropriate for the goals of the project. We ran several successive tests, adjusting the brinkmanship parameters each time to improve performance. We encountered some cases where the rover behaved inconsistently, such as when the rover's trajectory was not perpendicular to the edge of the cliff. We mounted several cameras around the test site to capture a variety of perspectives of the rover, and also filmed with a handheld smartphone camera. In the last test of the day, we also collected a rosbag file that contained the point clouds published by the Realsense camera. We will analyze this rosbag in order to further optimize our brinkmanship and navigation software, in order to achieve the best possible performance in future demonstrations of the system.
